Environmental Advisory Board (EAB) Meeting Robins Air Force Base

August 4, 2022

Solid Waste Management Units (SWMUs) 59 & 60 (CG501 & CG502) - Update on Progress

SWMU 62 (OT037) - Update on Progress

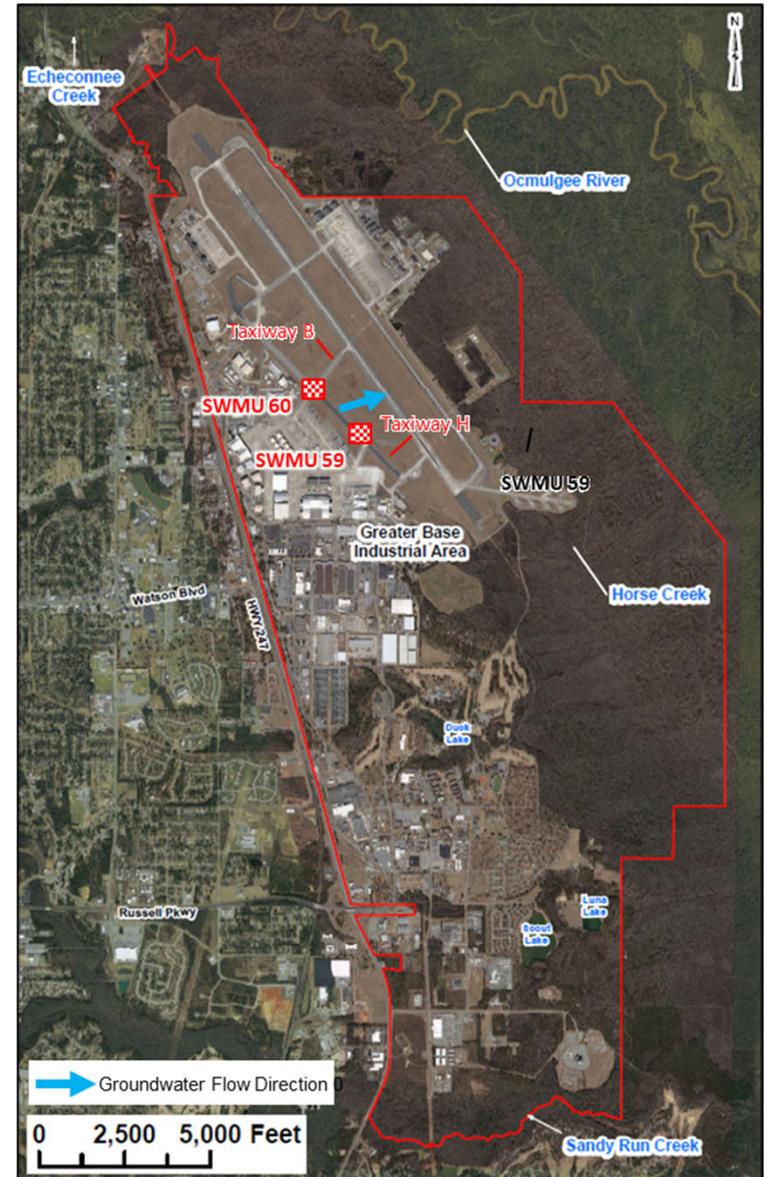
SWMU 59 and 60 Location

- Located in flightline area
- 1995: Petroleum contamination discovered due to presumed historical release(s) from active/inactive buried fuel lines
- Inactive fuel line transported Jet Propellant Number 4 (JP-4) until mid-1990s and abandoned in place in 2000
- Active fuel line transported JP-4 until mid-1990s when Robins AFB converted to JP-8 for aircraft fueling
- Historical release of light non-aqueous phase liquid (LNAPL) resulted in groundwater plume
- Numerous investigations have found no evidence of ongoing leak

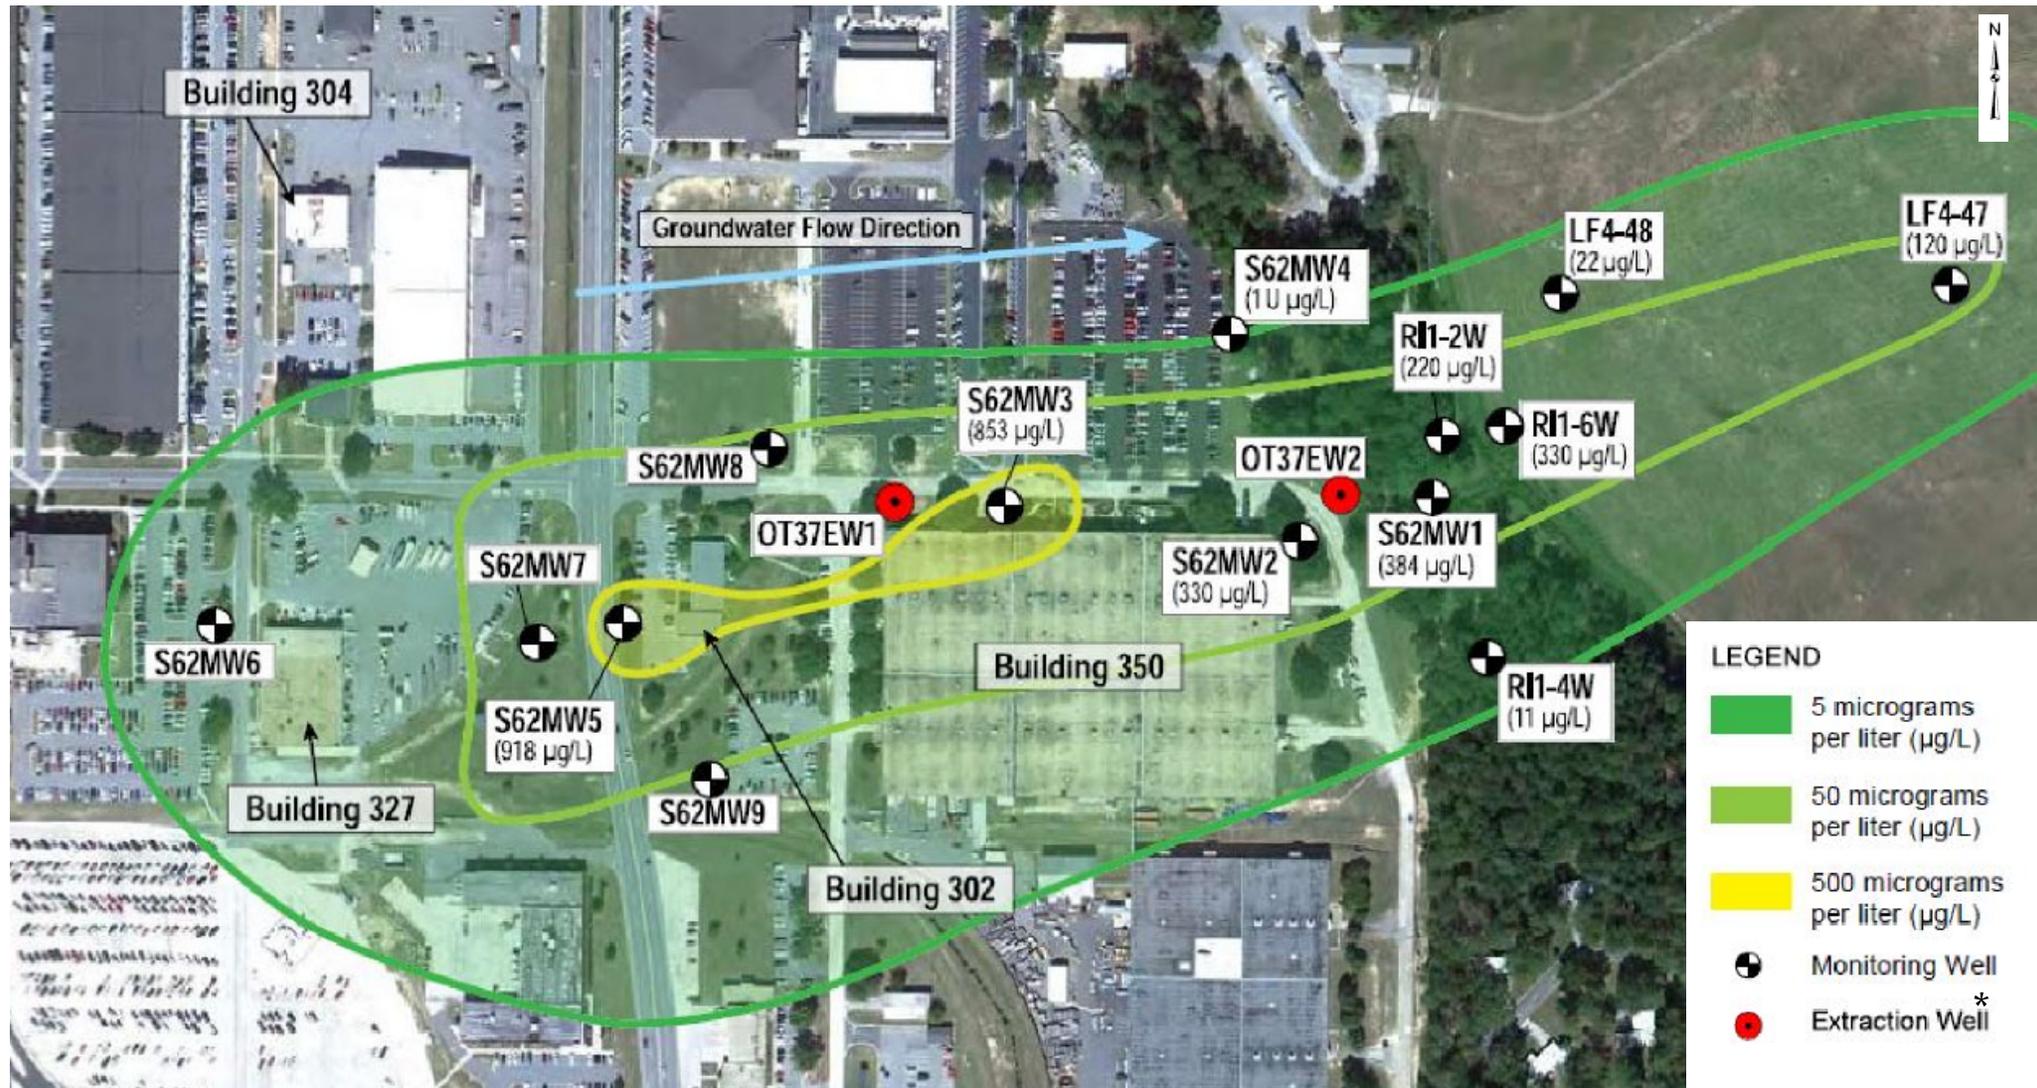
TCE Plume (May 1999)

* Pumping initiated 2002; shown on figure for reference purposes only
